MISCELLANEOUS PAPER CERC-85-9

SIDE-SCAN SONAR OF BAILEY'S DAM, RED RIVER, ALEXANDRIA, LOUISIANA

Joan Pope

September 1985

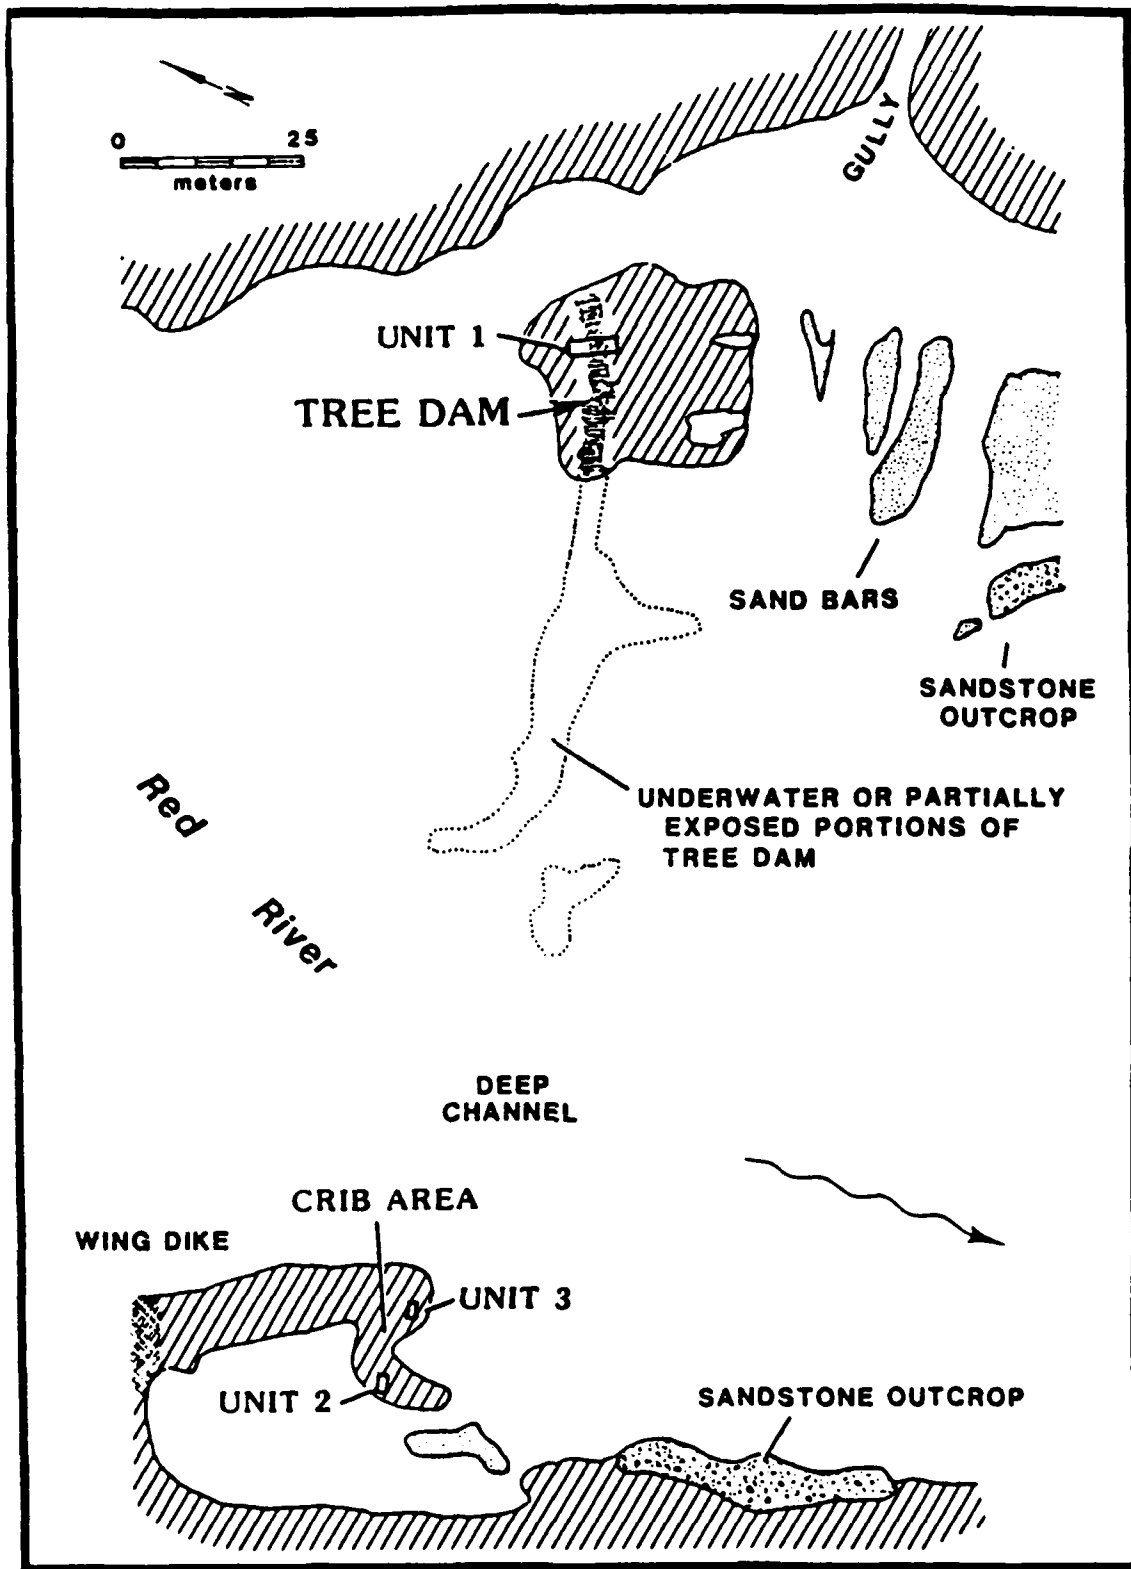
2. Although the lower dam is accessible during very low water, both structures were completely submerged at the time of this survey and navigation of the Red River was not impeded by the presence of these structures. Figure 2 is a stylized drawing of the original Civil War project. A large portion of the lower dam was constructed of layers of cut timber fashioned into a "Tree Dam" which extended across approximately half the channel from the north bank, a deep channel or "chute" across a third of the channel, and a few standard timber cribs along the south bank (Figure 3). Originally the upper dam consisted of a line of timber cribs built halfway across the channel from the south bank, a chute, and an arrowhead arrangement of a Tree Dam and a "Bracket Dam" built out from the north bank (Figure 2). Figures 1 and 4 may be used to illustrate the approximate location of these structures relative to modern features.

Figure 3. Plan of present condition of Lower Bailey's Dam
(Coastal Environments, Inc. 1984)
